Photographs for Mid City Plating Company CEI 6/22/2010

Media: RCRA

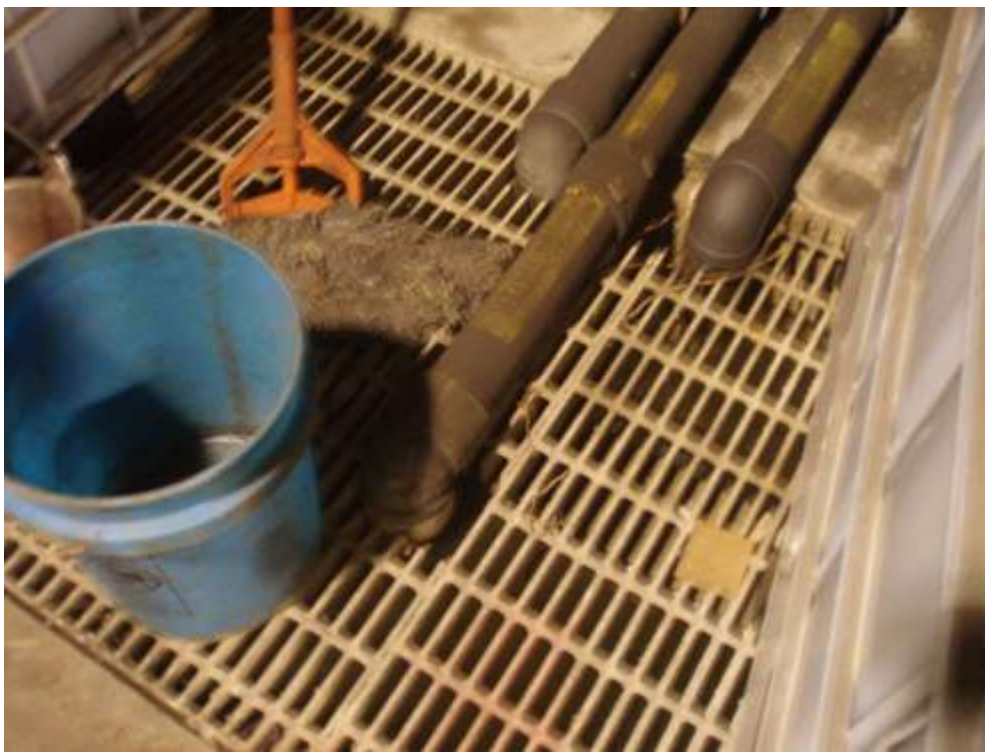
Disk Number 1
Photo Number 1
Photo Filename P6220094.JPG
Date/Time 6/22/2010
9:14:06 AM
Photographer Jamie Paulin

Hanson Plating Machine trench. Waste water from plating line was collected in trench and was manually pumped into WWT unit. Line had not been in operation since January 2010.

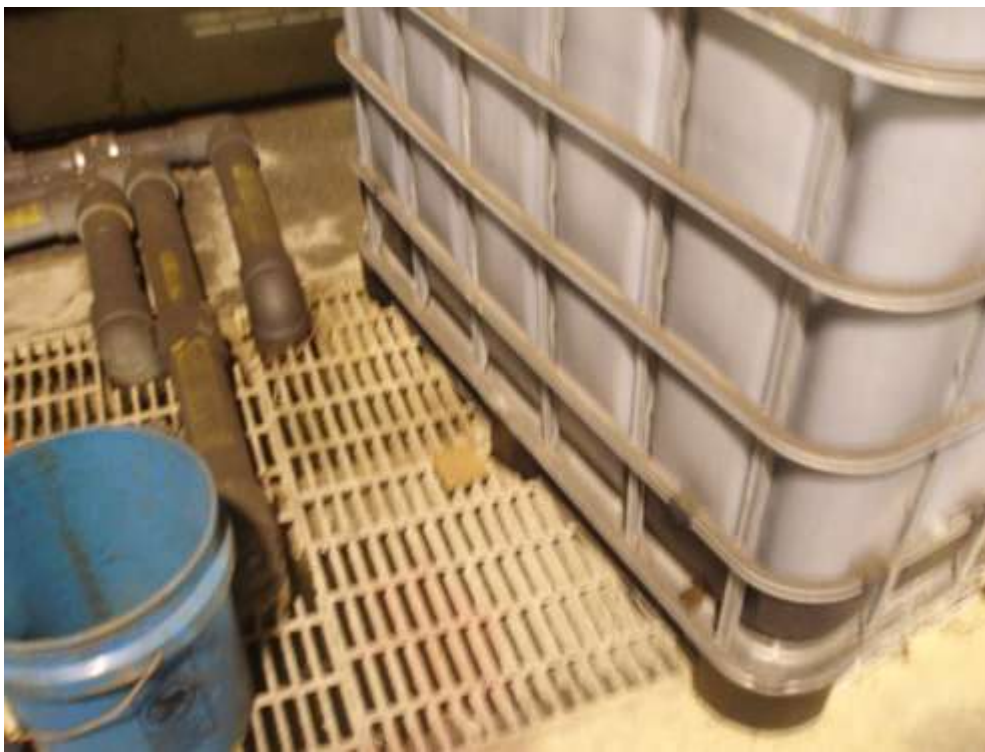
Disk Number 1
Photo Number 2
Photo Filename P6220095.JPG
Date/Time 6/22/2010
9:14:18 AM
Photographer Jamie Paulin

Hanson Plating Machine trench. Waste water from plating line was collected in trench and was manually pumped into WWT unit. Line had not been in operation since January 2010. Liquid was located inside of trench at time of inspection.

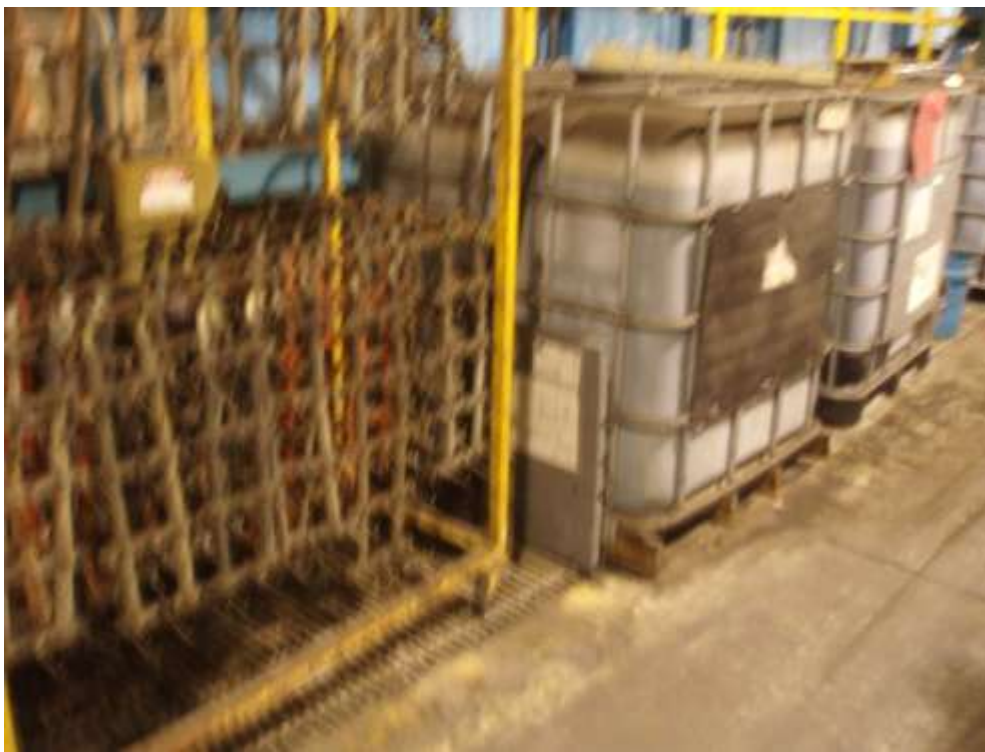
Disk Number 1
Photo Number 3
Photo Filename P6220096.JPG
Date/Time 6/22/2010
9:16:20 AM
Photographer Jamie Paulin

Hanson Plating Machine. Materials were being stored inside of totes located near plating line. Plating line had not been used since January 2010.

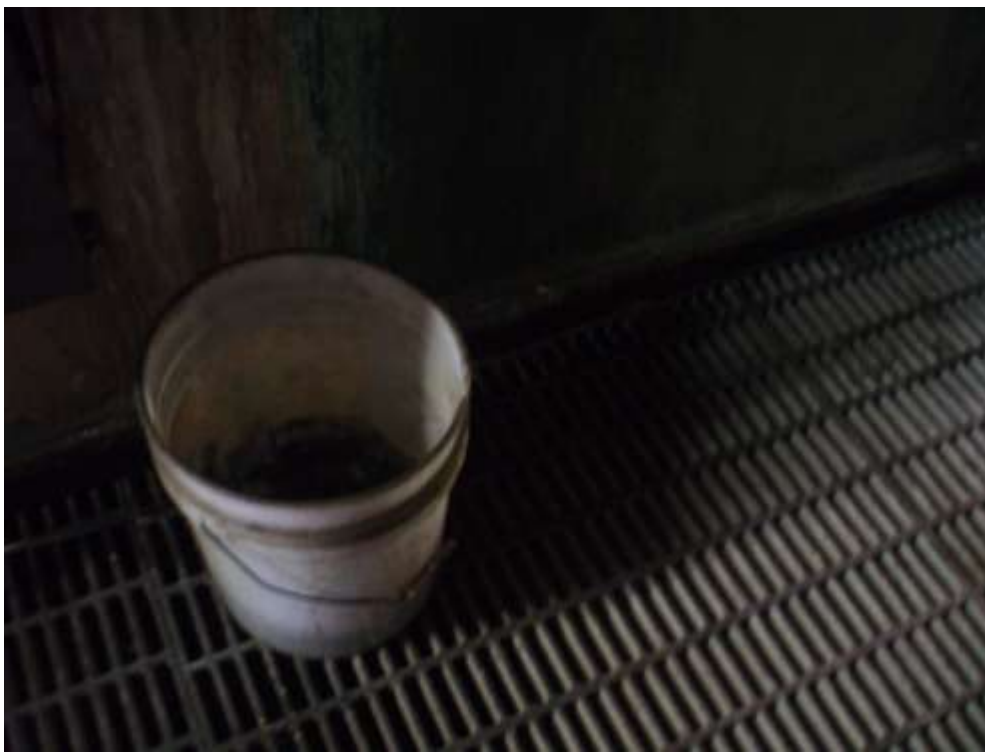
Disk Number 1
Photo Number 4
Photo Filename P6220097.JPG
Date/Time 6/22/2010
9:19:46 AM
Photographer Jamie Paulin

Open bucket of material located on trench near the E-coat line. E-coat line was in operation 1 or 2 shifts per month.

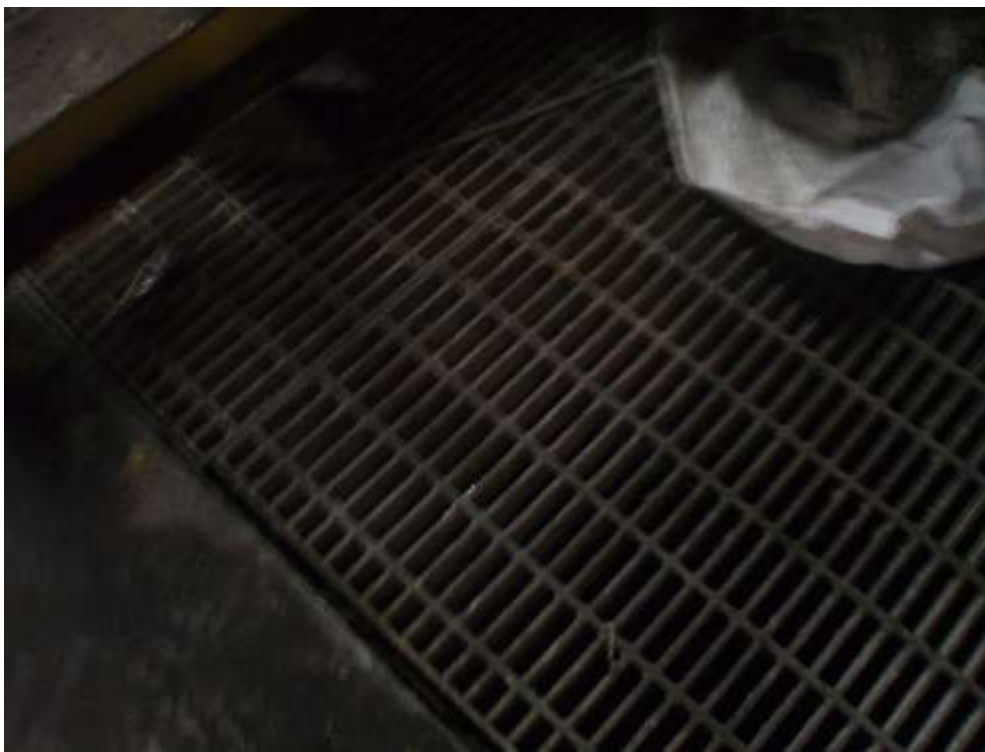
Disk Number 1
Photo Number 5
Photo Filename P6220098.JPG
Date/Time 6/22/2010
9:21:08 AM
Photographer Jamie Paulin

Trench located near E-coat line. Trench collected waste water to be pumped into WWT unit periodically.

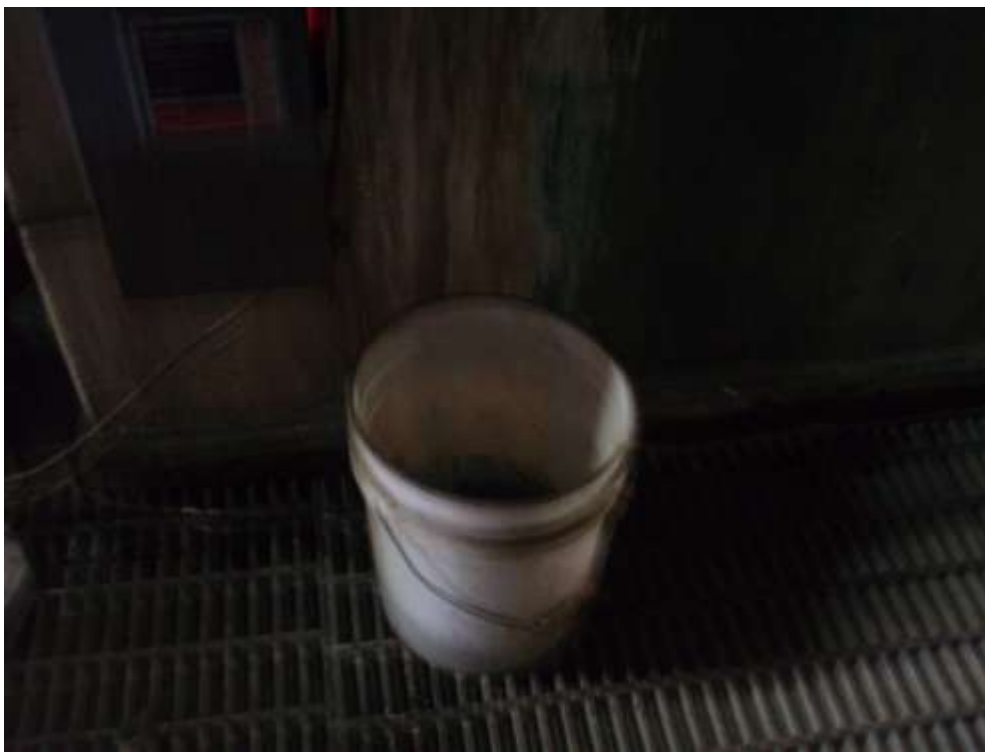
Disk Number 1
Photo Number 6
Photo Filename P6220099.JPG
Date/Time 6/22/2010
9:21:18 AM
Photographer Jamie Paulin

Open bucket of material located on trench near the E-coat line. E-coat line was in operation 1 or 2 shifts per month.

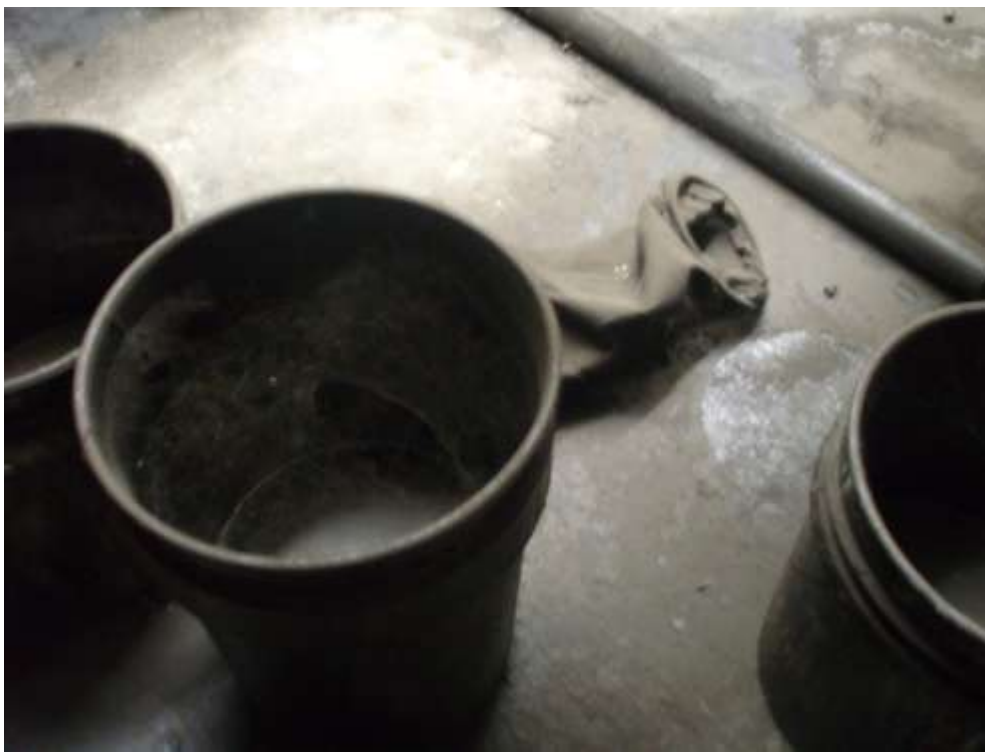
Disk Number 1
Photo Number 8
Photo Filename P6220101.JPG
Date/Time 6/22/2010
9:27:26 AM
Photographer Jamie Paulin

3 open buckets of un-identified material were being stored on the floor near E-coat line. Spider webs/cob webs were located inside of buckets.

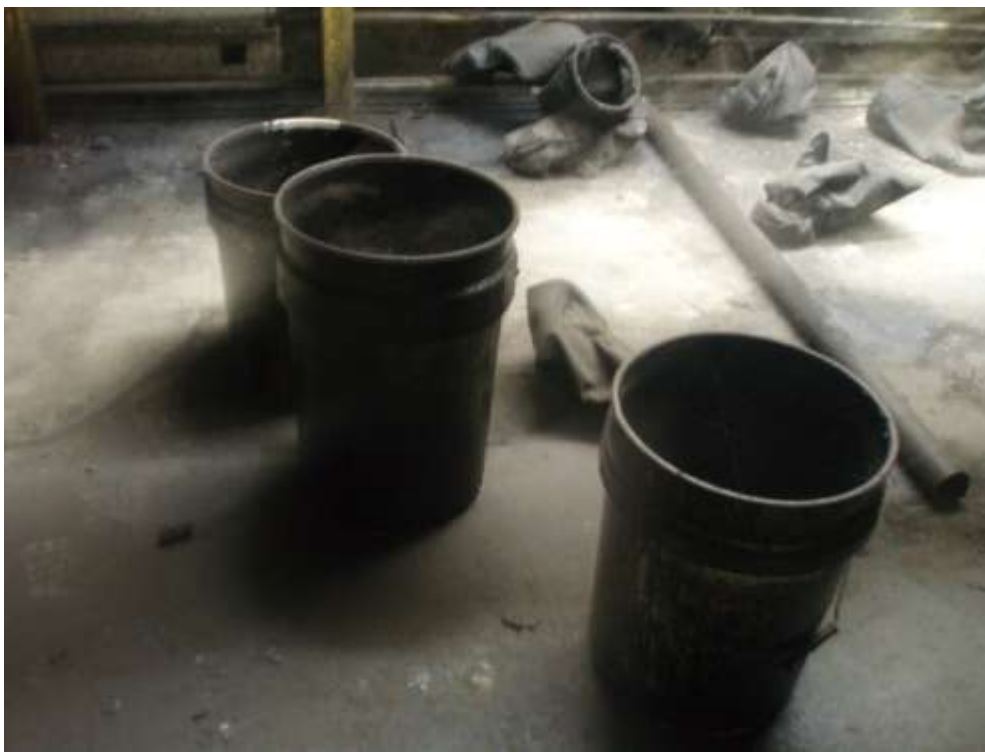
Disk Number 1
Photo Number 9
Photo Filename P6220102.JPG
Date/Time 6/22/2010
9:27:34 AM
Photographer Jamie Paulin

3 open buckets of un-identified material were being stored on the floor near E-coat line. Spider webs/cob webs were located inside of buckets.

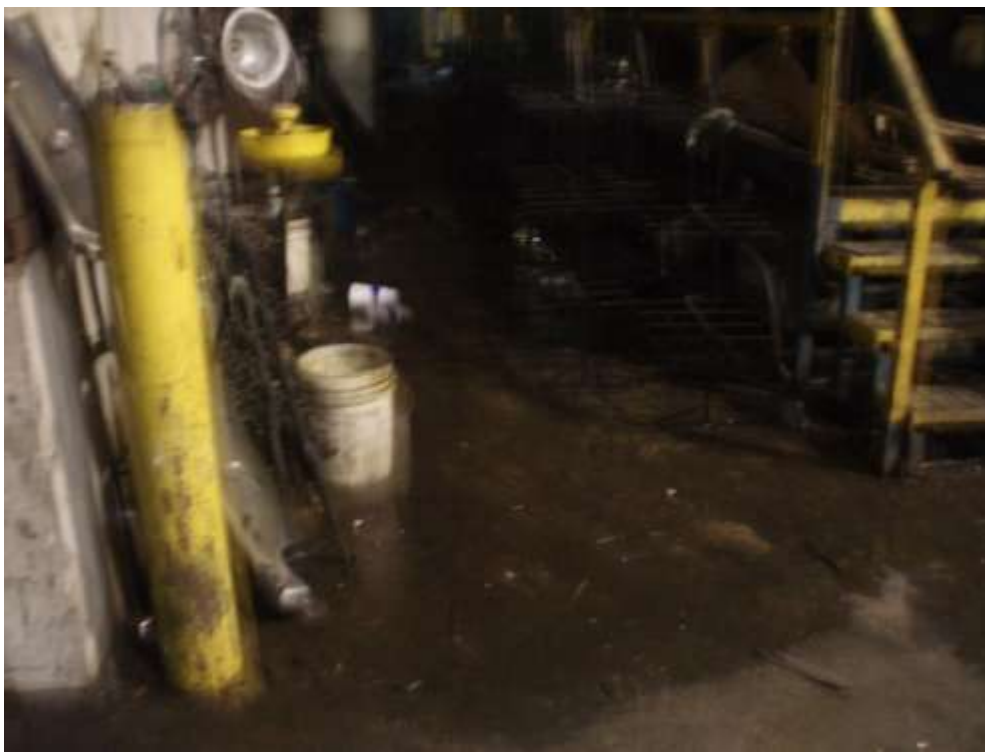
Disk Number 1
Photo Number 10
Photo Filename P6220103.JPG
Date/Time 6/22/2010
9:32:20 AM
Photographer Jamie Paulin

Liquid was located on the floor near plating line. Open bucket of material was also located in this area.

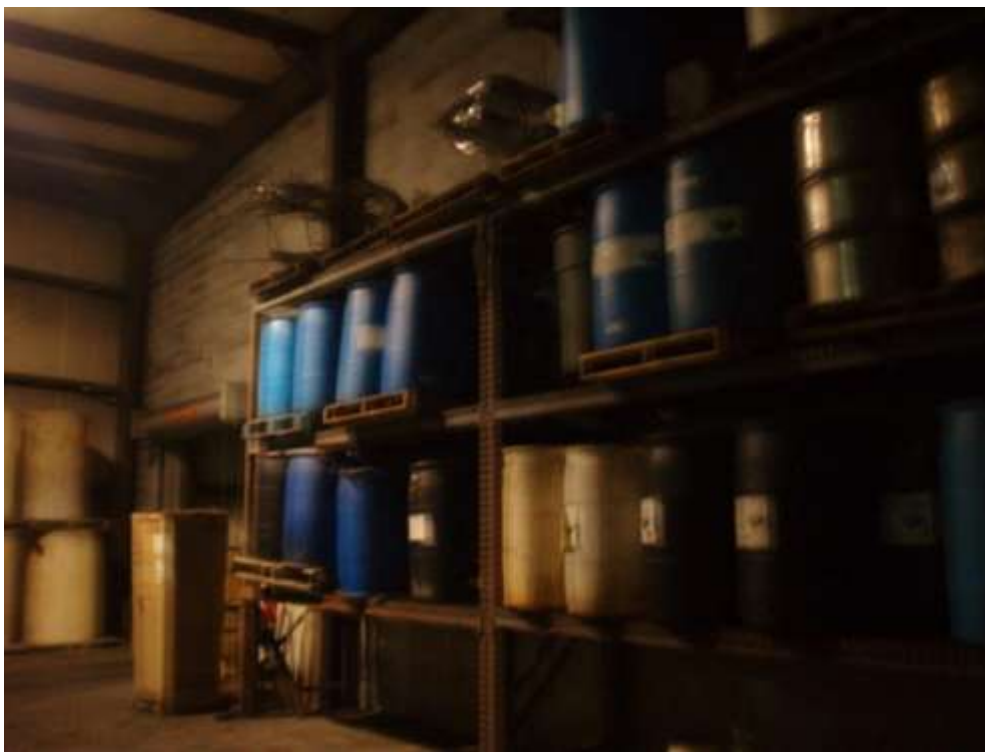
Disk Number 1
Photo Number 13
Photo Filename P6220106.JPG
Date/Time 6/22/2010
9:35:04 AM
Photographer Jamie Paulin

3-tiered shelving unit. 55-gallon containers were being stored on the shelves. The containers were described as storing oil.

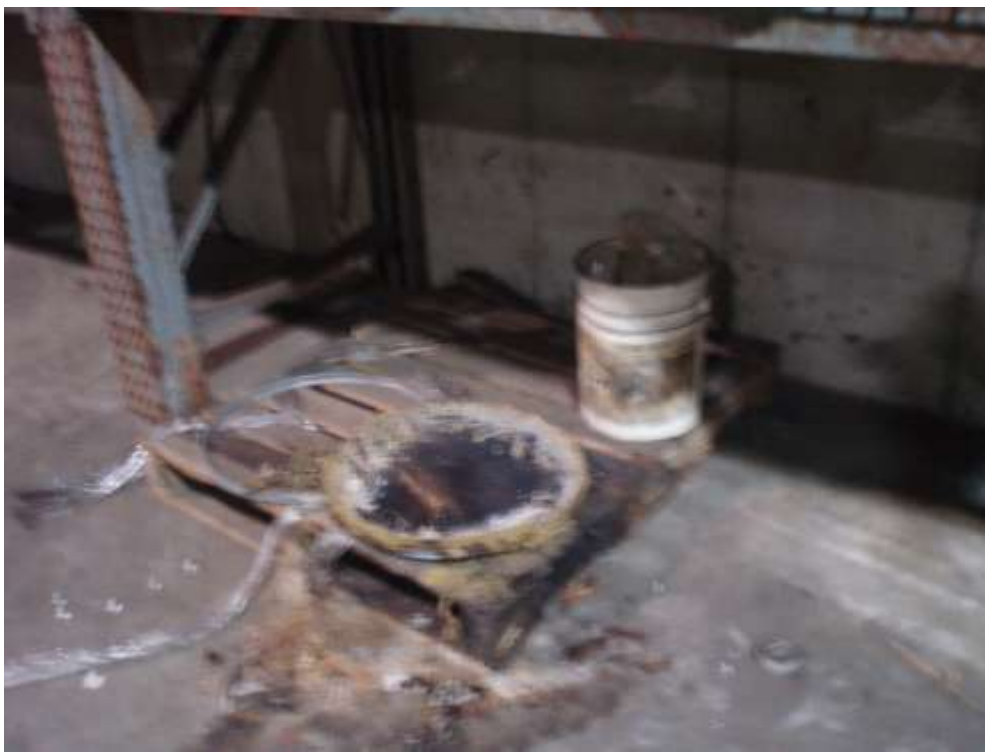
Disk Number 1
Photo Number 15
Photo Filename P6220108.JPG
Date/Time 6/22/2010
9:37:26 AM
Photographer Jamie Paulin

An open bucket, containing a material, was being stored in the raw material area on a pallet. A corroded metal lid was also being stored on the pallet.

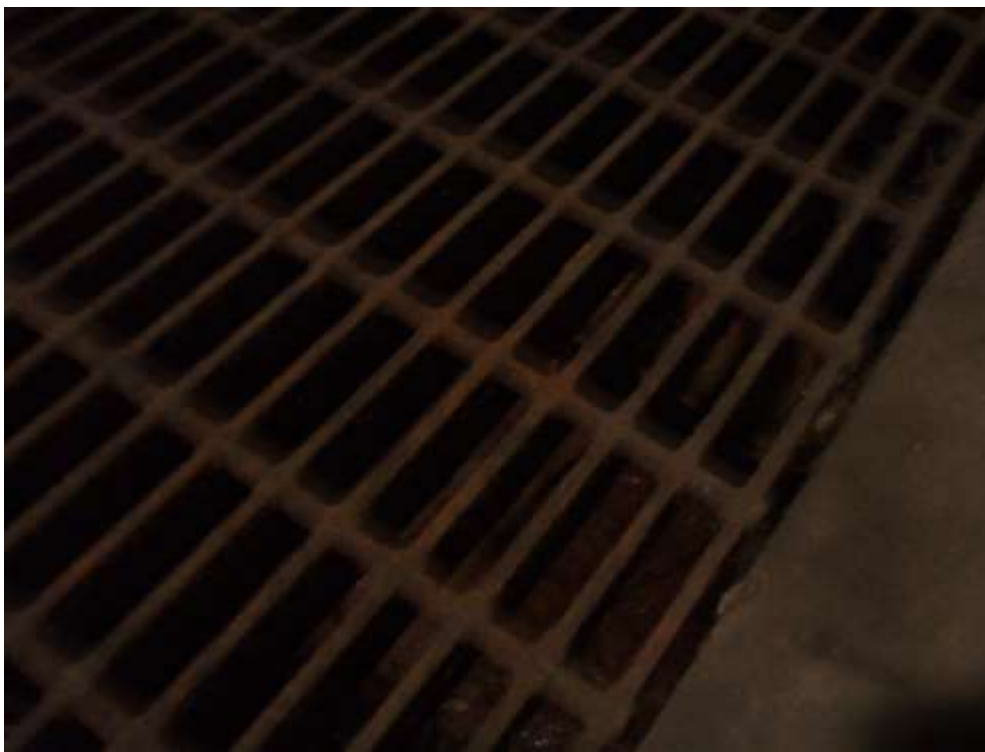
Disk Number 1
Photo Number 16
Photo Filename P6220109.JPG
Date/Time 6/22/2010
9:39:14 AM
Photographer Jamie Paulin

A pit, with a grate, was located near the WWT unit waste water storage totes. A 4-inch thick un-identified solid material was located in the bottom of the pit.

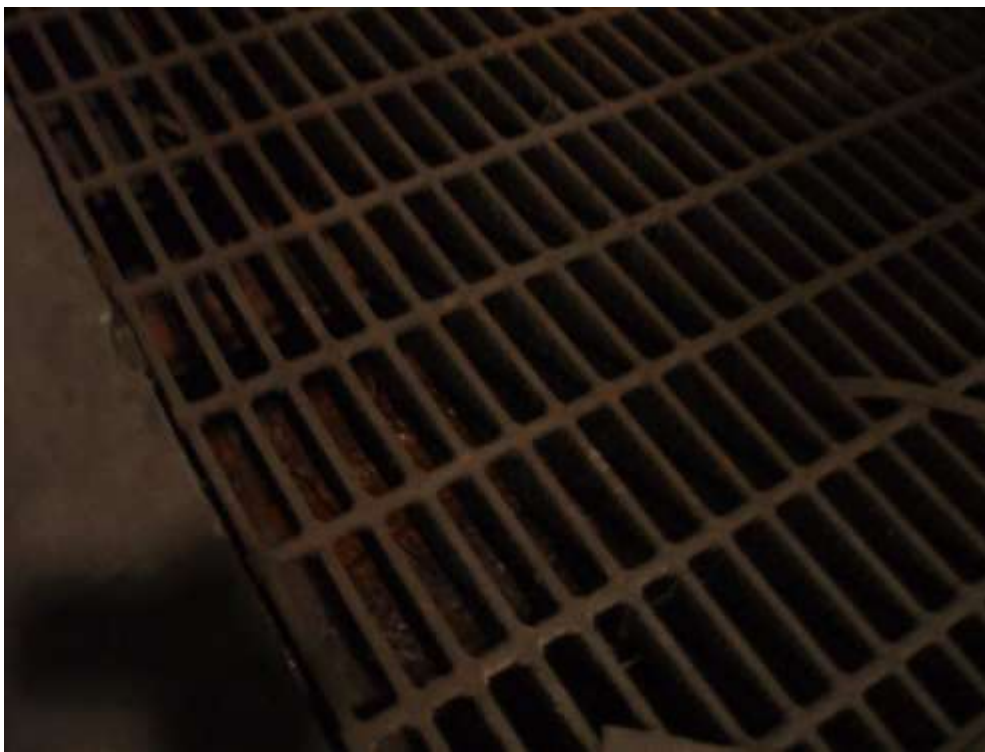
Disk Number 1
Photo Number 17
Photo Filename P6220110.JPG
Date/Time 6/22/2010
9:39:36 AM
Photographer Jamie Paulin

A pit, with a grate, was located near the WWT unit waste water storage totes. A 4-inch thick un-identified solid material was located in the bottom of the pit.

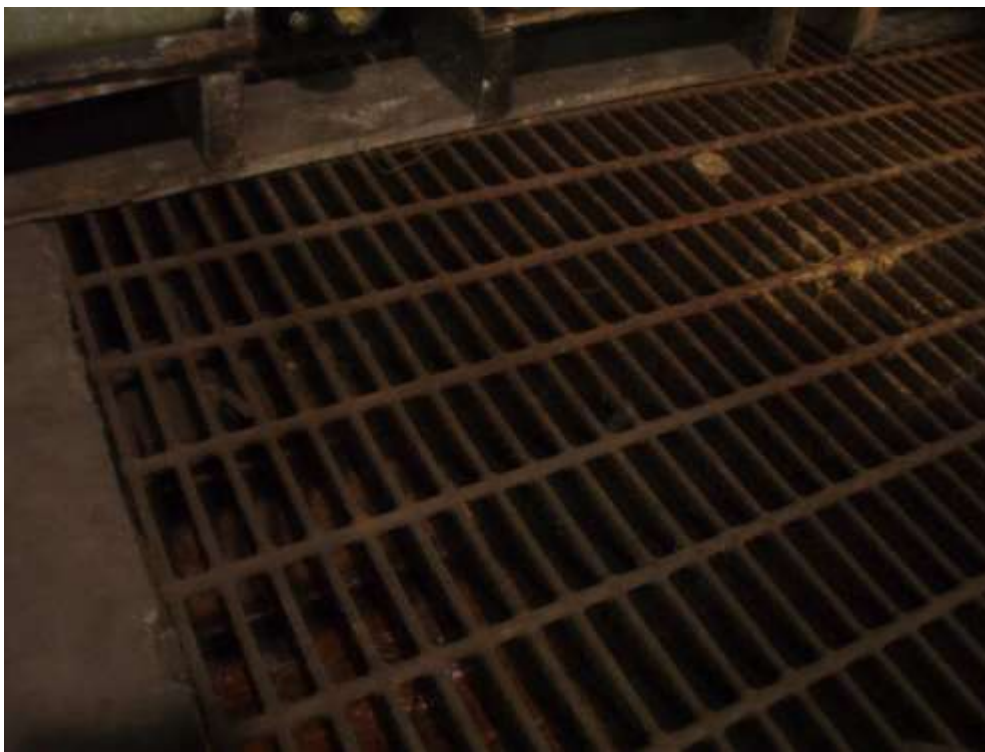
Disk Number 1
Photo Number 18
Photo Filename P6220111.JPG
Date/Time 6/22/2010
9:39:44 AM
Photographer Jamie Paulin

A pit, with a grate, was located near the WWT unit waste water storage totes. A 4-inch thick un-identified solid material was located in the bottom of the pit.

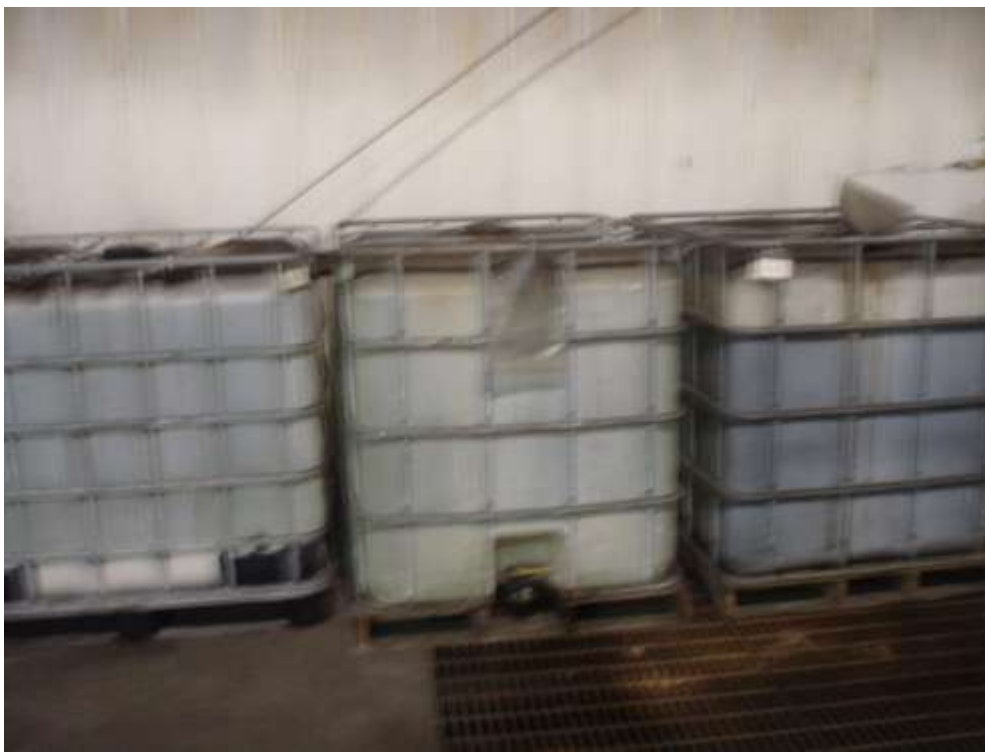
Disk Number 1
Photo Number 19
Photo Filename P6220112.JPG
Date/Time 6/22/2010
9:40:06 AM
Photographer Jamie Paulin

Totes that contained various plating line waste water prior to be treated in the WWT unit were being stored near the collection pit. The totes were not labeled or dated.

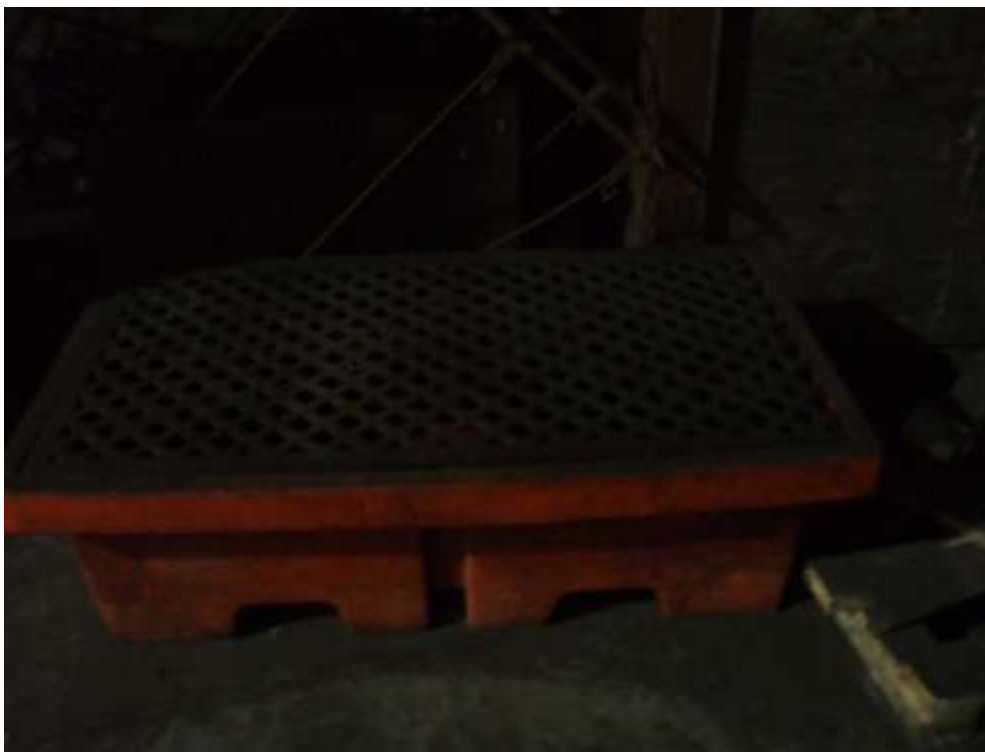
Disk Number 1
Photo Number 22
Photo Filename P6220115.JPG
Date/Time 6/22/2010
9:48:36 AM
Photographer Jamie Paulin

A plastic pallet was being stored near the WWT unit waste water storage totes. An unidentified liquid was located inside of the pallet.

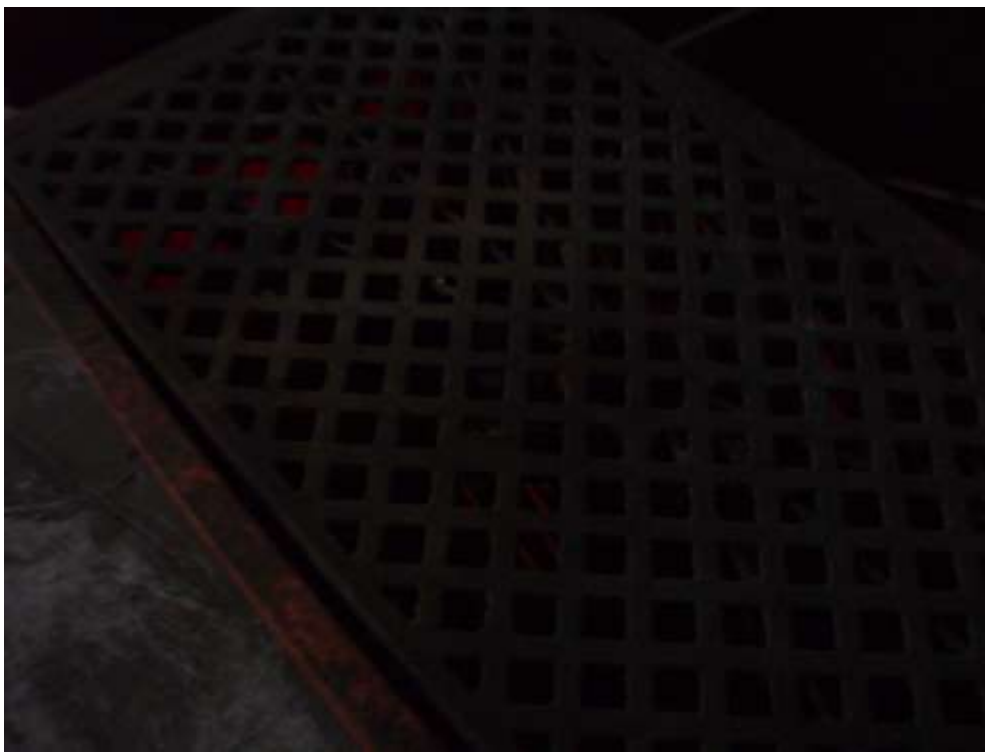
Disk Number 1
Photo Number 23
Photo Filename P6220116.JPG
Date/Time 6/22/2010
9:48:48 AM
Photographer Jamie Paulin

A plastic pallet was being stored near the WWT unit waste water storage totes. An unidentified liquid was located inside of the pallet.

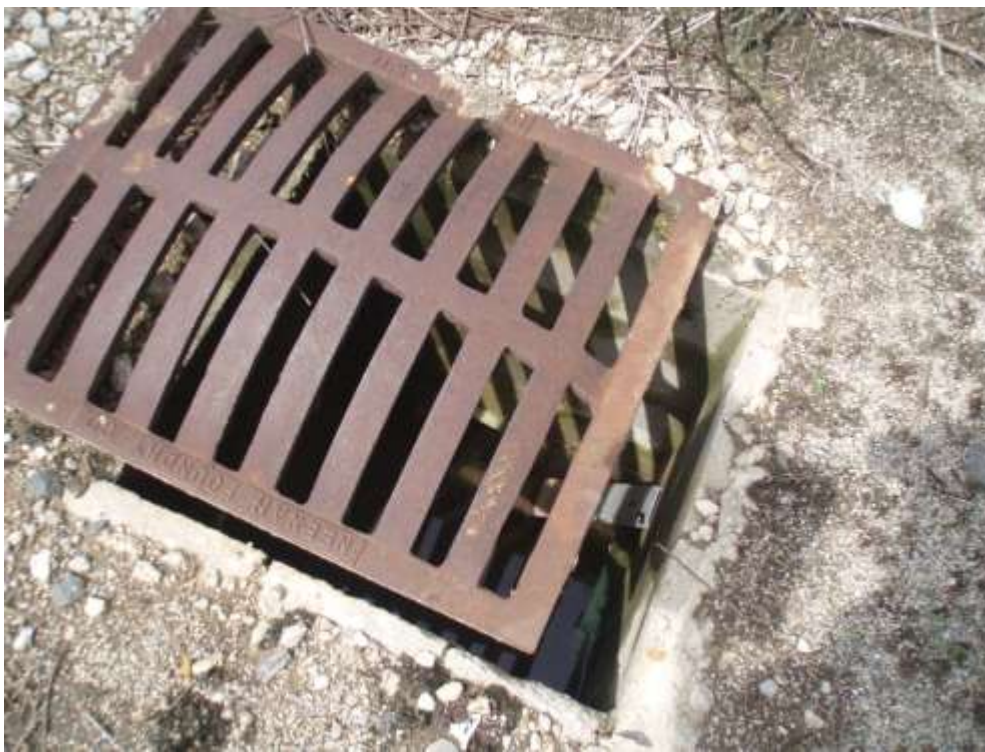
Disk Number 1
Photo Number 29
Photo Filename P6220122.JPG
Date/Time 6/22/2010
9:58:18 AM
Photographer Jamie Paulin

A storm water reservoir was located outside on the East side of the facility. The grid covering was not safely placed on the reservoir.

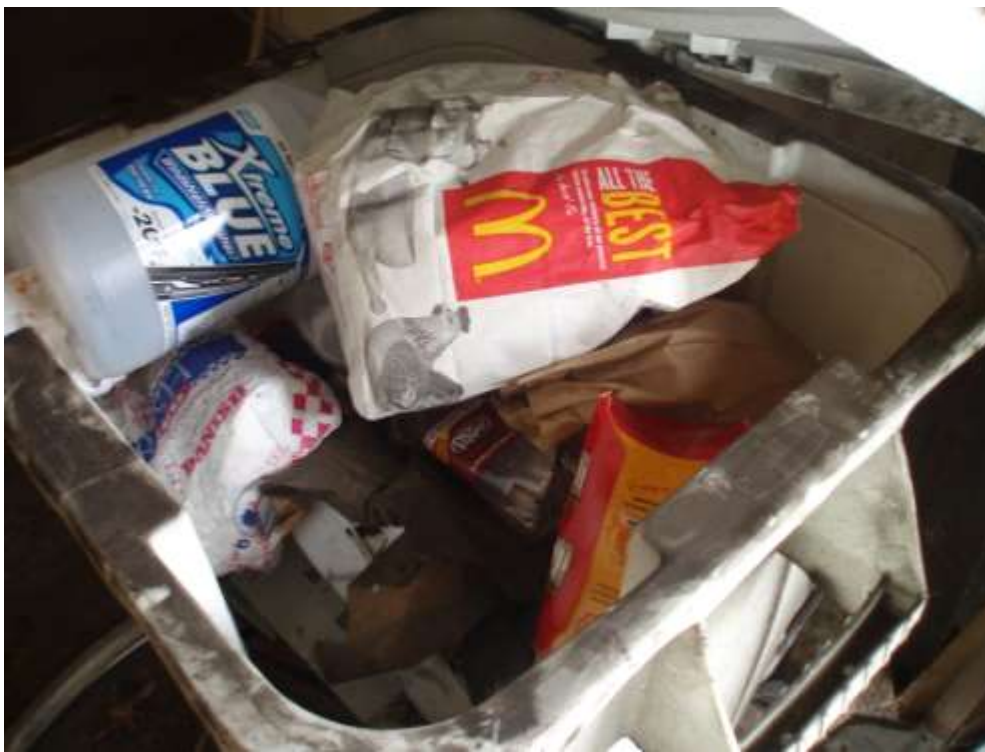
Disk Number 1
Photo Number 35
Photo Filename P6220128.JPG
Date/Time 6/22/2010
10:05:58 AM
Photographer Jamie Paulin

The spill kit was being stored on the East side of the facility, not near hazardous waste storage. The spill kit container was being used as a garbage can at the time of the inspection.

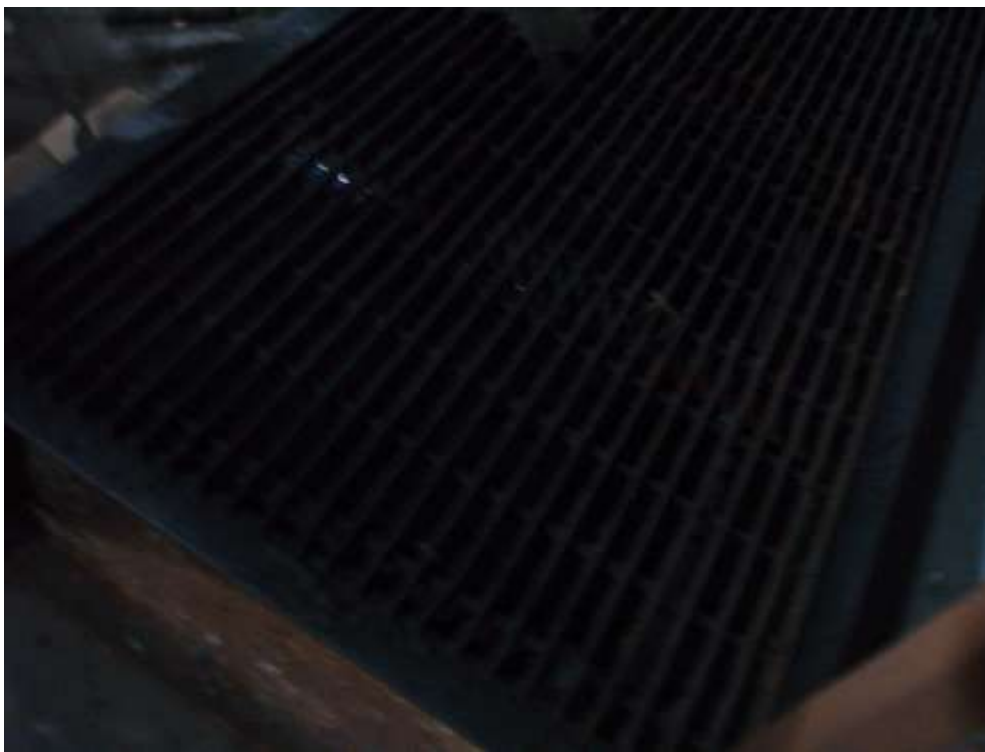
Disk Number 1
Photo Number 36
Photo Filename P6220129.JPG
Date/Time 6/22/2010
10:08:42 AM
Photographer Jamie Paulin

Used oil was being stored inside of a pit that was located in the barrel row plating line room.

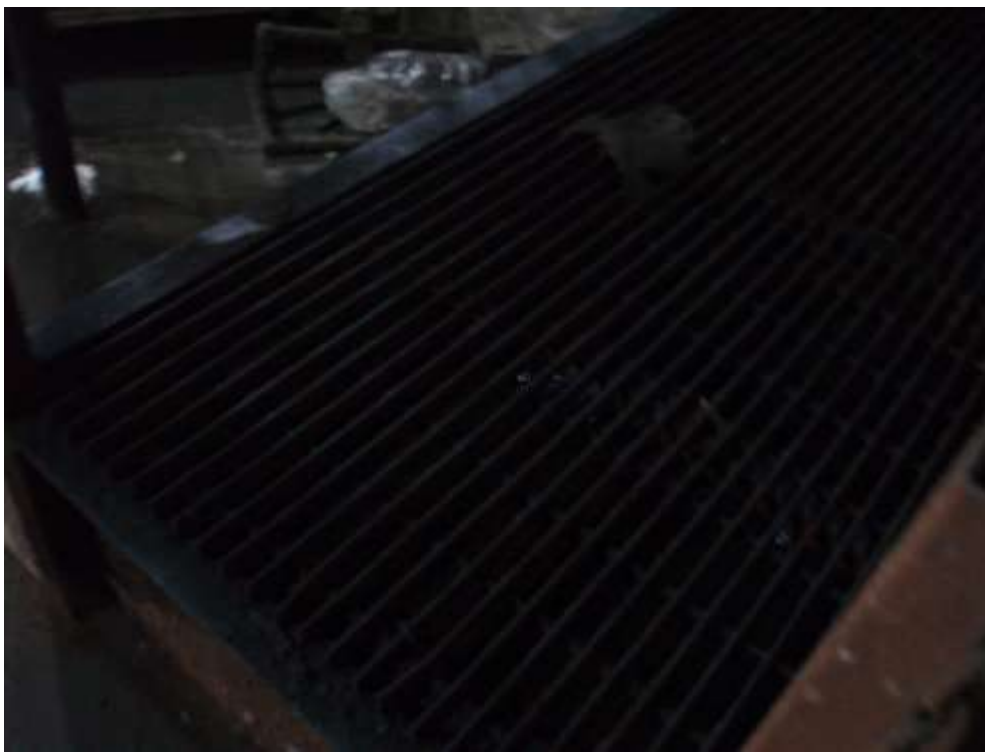
Disk Number 1
Photo Number 37
Photo Filename P6220130.JPG
Date/Time 6/22/2010
10:08:52 AM
Photographer Jamie Paulin

Used oil was being stored inside of a pit that was located in the barrel row plating line room.

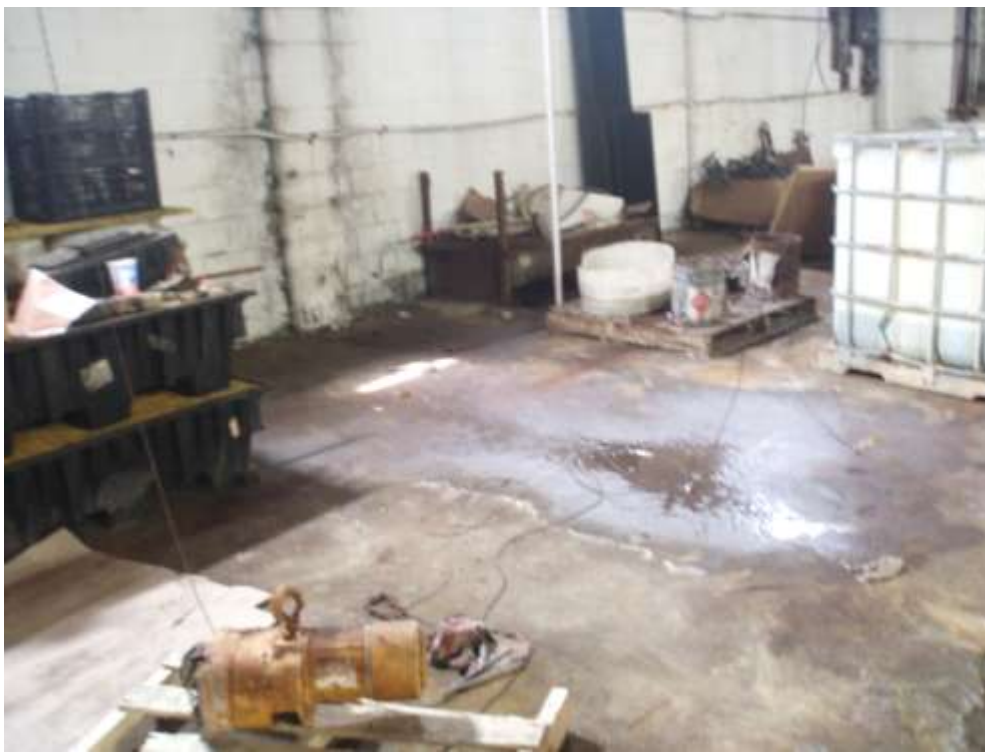
Disk Number 1
Photo Number 39
Photo Filename P6220132.JPG
Date/Time 6/22/2010
10:12:22 AM
Photographer Jamie Paulin

Barrel Row Line had been removed. Liquid was located on the floor. Equipment was being stored within the area.

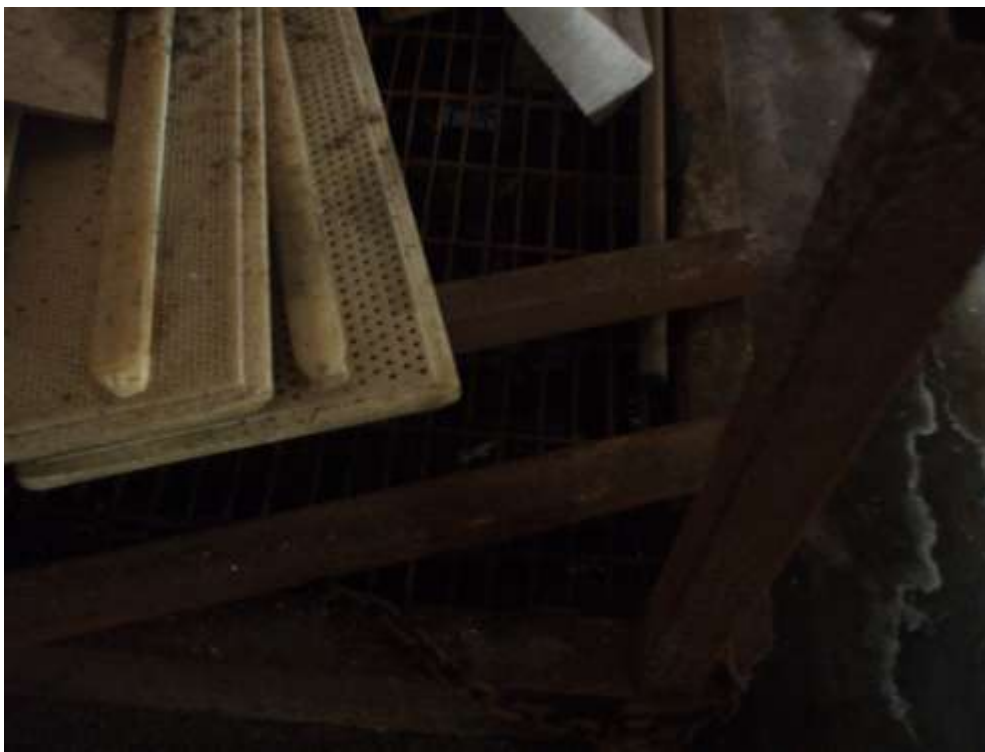
Disk Number 1
Photo Number 40
Photo Filename P6220133.JPG
Date/Time 6/22/2010
10:13:02 AM
Photographer Jamie Paulin

Barrel Row Line had been removed. Liquid and other material were located on the floor. Equipment was being stored within the area.

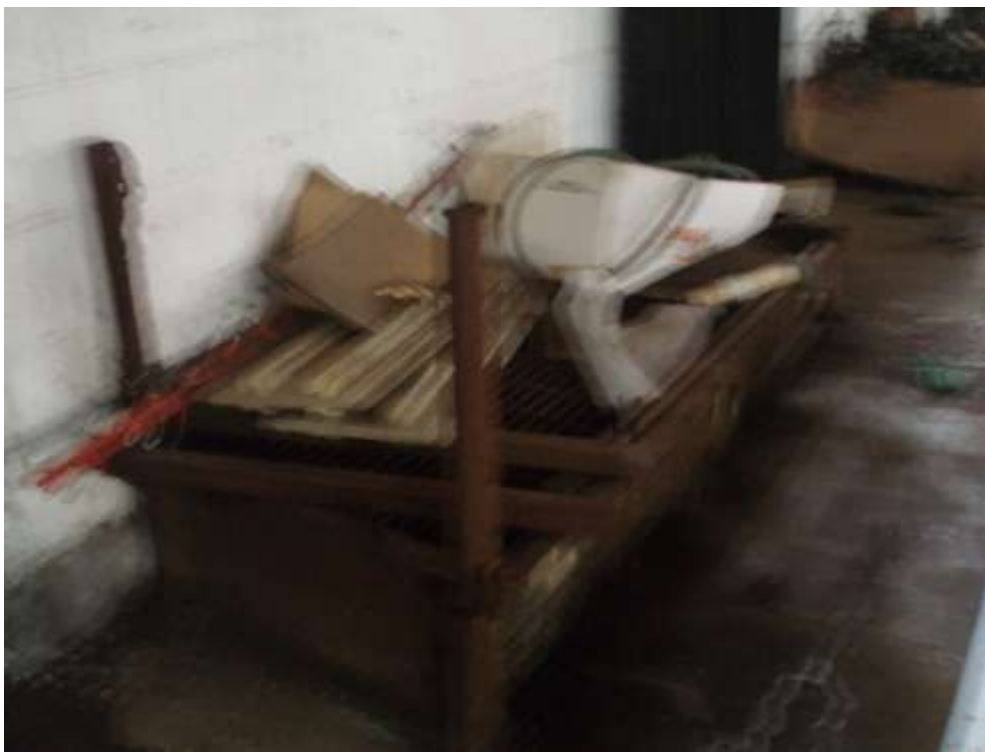
Disk Number 1
Photo Number 41
Photo Filename P6220134.JPG
Date/Time 6/22/2010
10:13:10 AM
Photographer Jamie Paulin

Barrel Row Line had been removed. Liquid and other material were located on the floor. Equipment was being stored within the area. Rectangular equipment was being used as an oil bin.

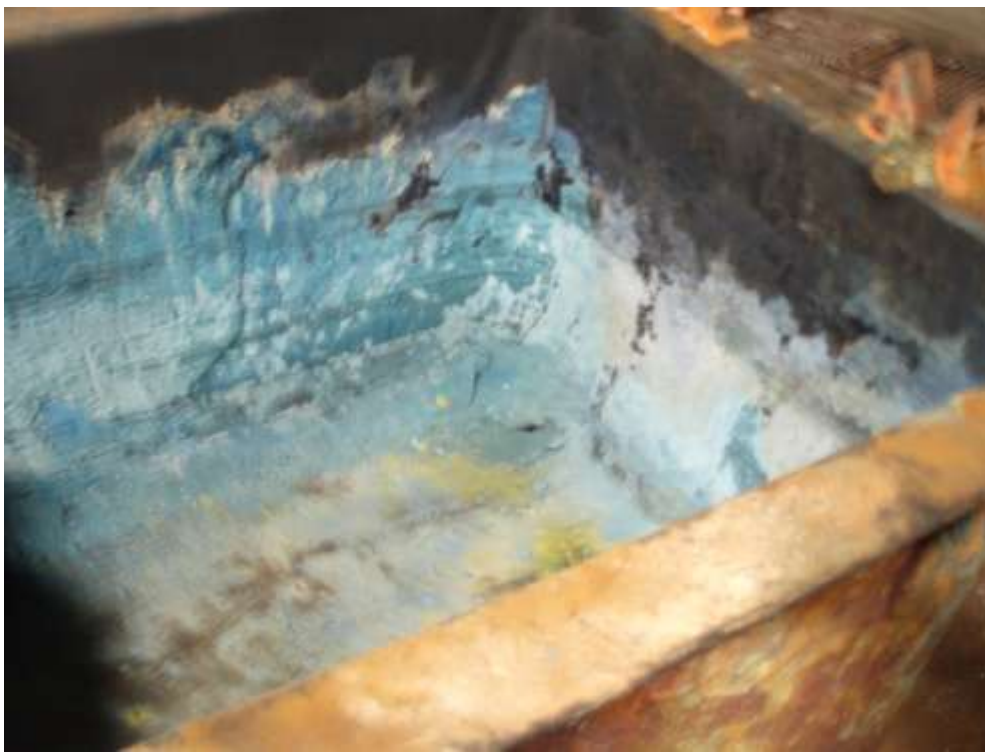
Disk Number 1
Photo Number 42
Photo Filename P6220135.JPG
Date/Time 6/22/2010
10:15:04 AM
Photographer Jamie Paulin

Barrel Row line bath. No liquid was located inside; however dried blue/white material was still located inside of bath. (Barrel Row line had been discontinued and tank was going to be dismantled.)

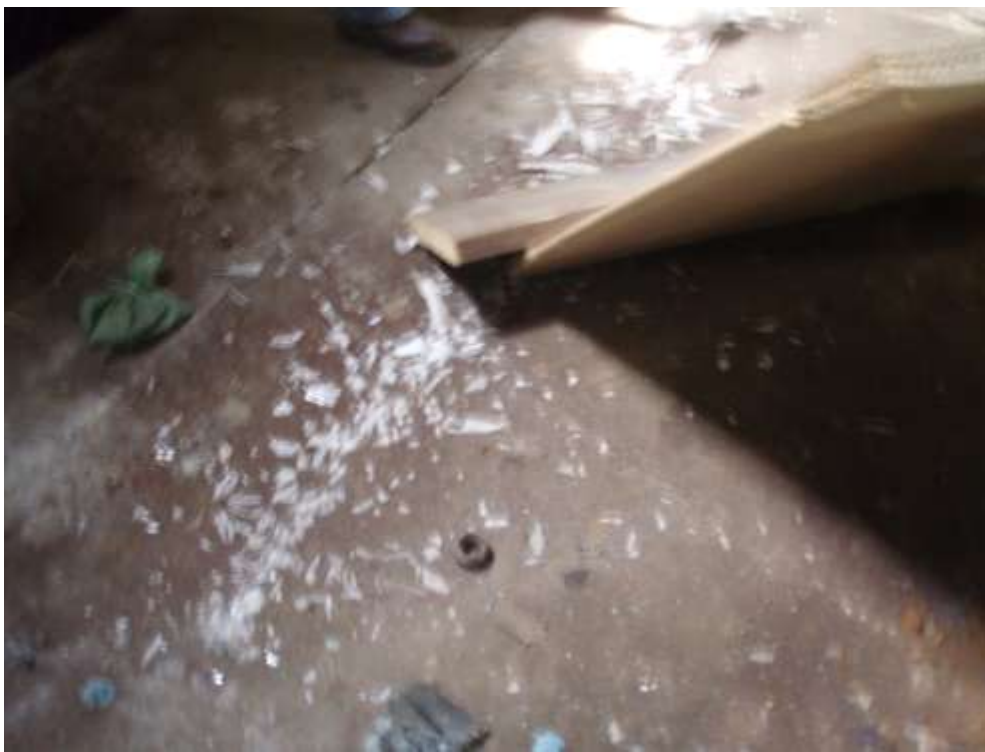
Disk Number 1
Photo Number 43
Photo Filename P6220136.JPG
Date/Time 6/22/2010
10:15:12 AM
Photographer Jamie Paulin

Broken fluorescent light bulb was located on the floor in the Barrel Row line room.

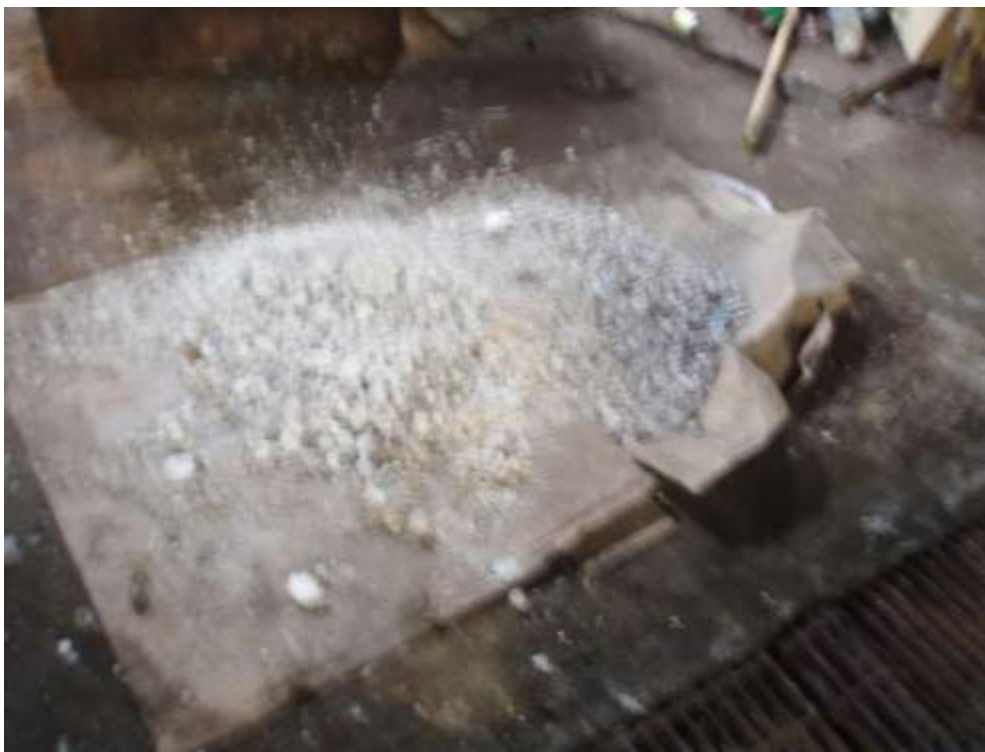
Disk Number 1
Photo Number 44
Photo Filename P6220137.JPG
Date/Time 6/22/2010
10:15:56 AM
Photographer Jamie Paulin

Zinc metal was being stored on a piece of fabric, located on the floor, near the Barrel Row line.

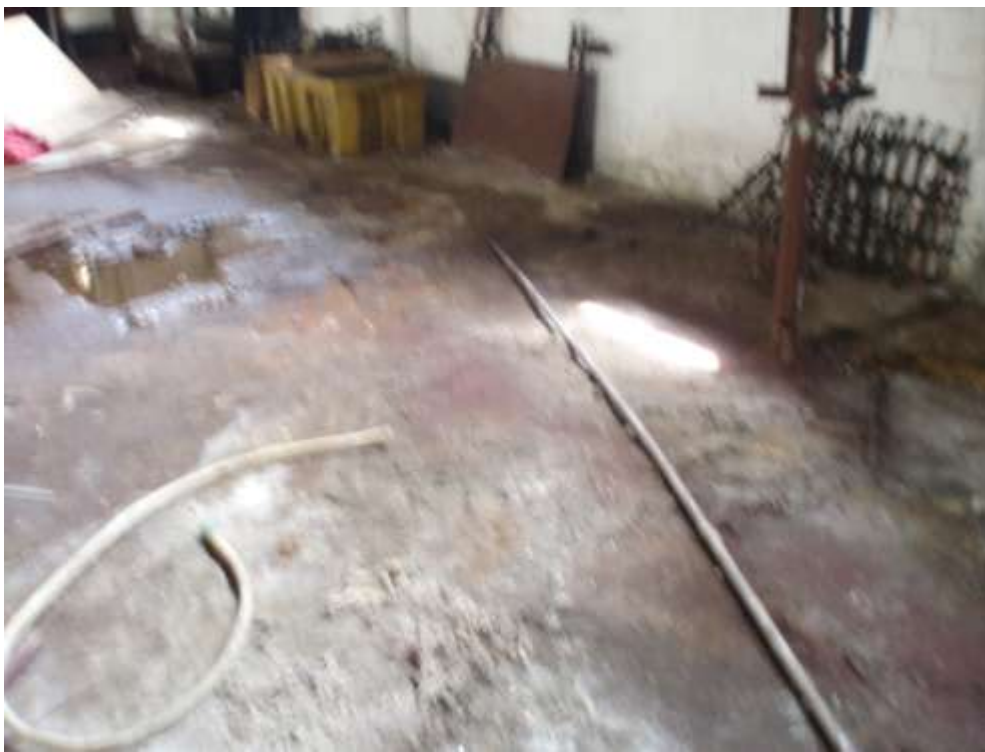
Disk Number 1
Photo Number 46
Photo Filename P6220139.JPG
Date/Time 6/22/2010
10:18:06 AM
Photographer Jamie Paulin

Barrel Row line location. Liquids were being stored on the floor. Equipment was being stored within the area.
